**STATEMENT OF
SIGNIFICANCE**

**ST. GEORGE'S PARK,
NATIONAL FOOTBALL
CENTRE**

**THE FOOTBALL
ASSOCIATION**

Date: April 2010

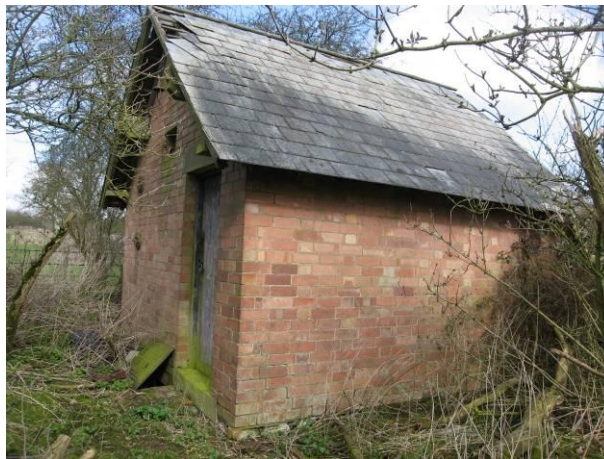
Plate 1

4.3.1.3 The pump house (**Plate 1**) stands just outside the western boundary of the application site. The pump house (marked as a 'pumping station' on the 1923 Ordnance Survey map) was constructed within a square enclosure between 1884 and 1901, in an area of trees north-west of the service court to Byrkley Lodge. It was built by Hamar A. Bass Esq. M.P. (1842-1898), who took over the leasehold of the estate from Colonel F.W. Newdigate in 1886, demolished the late 18th-century lodge and replaced it with a much larger house and service court between 1887 and 1901.

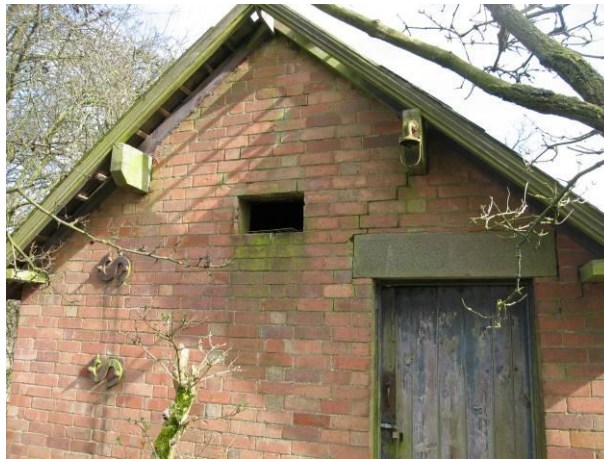
Plate 2

4.3.1.4 It is a small single-storey building of square plan form, constructed of red brick laid in Flemish Garden Wall Bond and with a slate-covered pitched roof. It has a simple collar and purlin roof structure of sawn timbers, the ends of the purlins projecting through the gable ends to support the overhanging eaves. The entrance is in the south-west elevation and comprises a simple boarded door beneath a broad concrete lintel and with a concrete step. There is a rectangular vent hole to each gable and a rooflight in the north-west roof slope. Fixed into the exposed purlin end above the door is an iron lamp-holder (**Plate 2**). The pump mechanism and well shaft survive within.

- 4.3.1.6 The building appears in fair condition, although cracking to the brickwork around and above the lintel is apparent. The lintel, which cuts rather crudely into the brickwork, may in fact be a replacement for an earlier timber lintel. There is also deterioration of the brickwork close to ground level beneath what may be an old slate damp-proof course, and there are slipped and missing slates to the ridge and the gable ends where the eaves overhang.

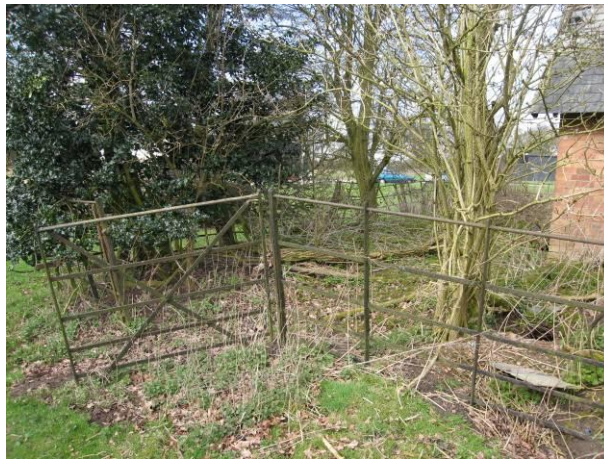
Plate 3

- 4.3.1.7 The enclosure around the building is defined by traditional cast-iron parkland-style railings, with an iron gate in the south-east side (**Plate 3**); these railings are almost certainly the original (late 19th-century) means of enclosure. The railings are leaning over in places and need re-setting; some have probably been pushed out by unchecked self-seeded tree growth within the enclosure.

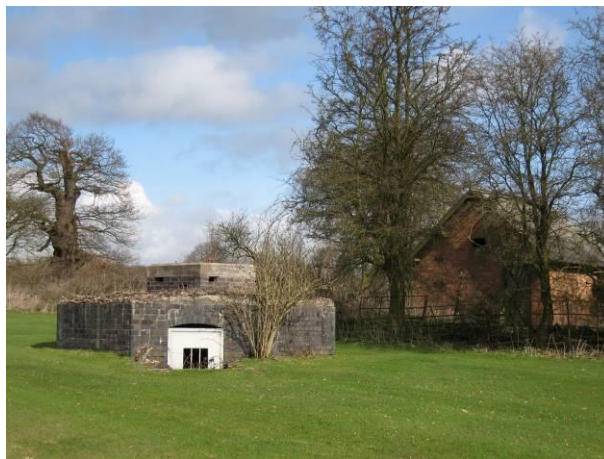
Plate 4

4.3.1.10 The icehouse (**Plate 4**) stands just outside the western boundary of the application site. It was constructed between 1901 and 1923 within a small enclosure adjoining the south-west side of the pump house enclosure; its enclosure boundary survived until 1955 but had been removed by 1974. It formed part of a wider improvement of services provision to Byrkley Lodge that included a new Gas Works built during the same period just to the north-west (now demolished) and an electricity power station south-west of the service court. The construction of the Gas Works was accompanied by a new access road, which opened off the drive crossing the park from east to west.

4.3.1.14 The building appears in fair condition, although the concrete capping to the main superstructure is deteriorating.

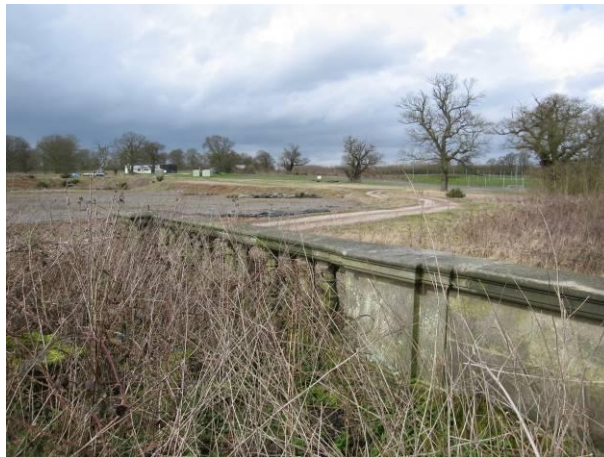
Plate 11

4.3.1.22 Where the wall turns to the west there is a decorative carved arched recess in the end of the corner block. The east-west continuation of the wall (**Plate 11**) also alternates an infilled panel with balustrading; again much of this has been removed. The wall turns inwards where it previously ended to allow access to a driveway.

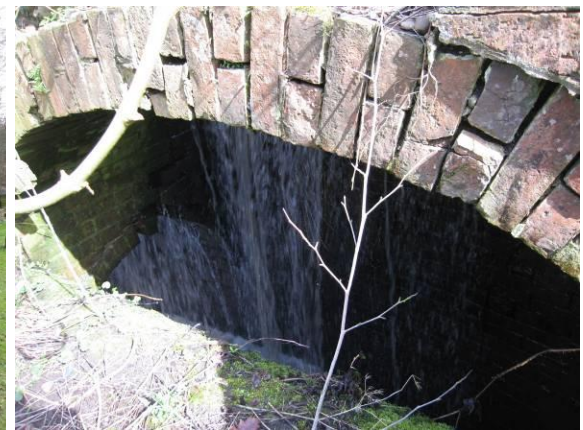
Plate 16

level present on the other side of the track to the south. The long narrow brick 'tank' created by the two walls is subdivided along its length by lateral walls creating five separate 'cells'. The dividing walls continue upwards to create a vaulted 'roof' to the structure and a series of five south-facing basket-arched openings, allowing one to view the water cascading down over the top of the north wall (**Plates 15 and 16**). The north wall appears to incorporate a slight 'bow' to each 'cell' (**Plate 17**). The two southern cells appear to be interconnected via an arched opening in their shared subdividing wall (see **Plate 16**).

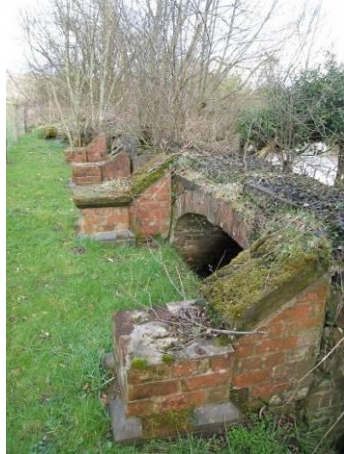
Plate 18

4.3.1.33 The structure is additionally supported on the south side by brick buttresses, originally coped with stone (**Plate 18**). Just behind the dam structure is a low cast-iron railing with close-set vertical uprights which acts as a filter to prevent debris being

4.3.1.34 The visible parts of the dam structure are constructed of a darkish red brick. The top of the dam structure is capped with stone and there is a stone keystone to the central arch (**Plate 21**). The buttresses appear to be later additions to the structure, constructed of an orange-red brick and not bonded into the brickwork of the main structure. These were originally capped with stone (most of this has been removed or fallen away) and have splayed plinths of blue brick with moulded capping (see **Plate 18**).

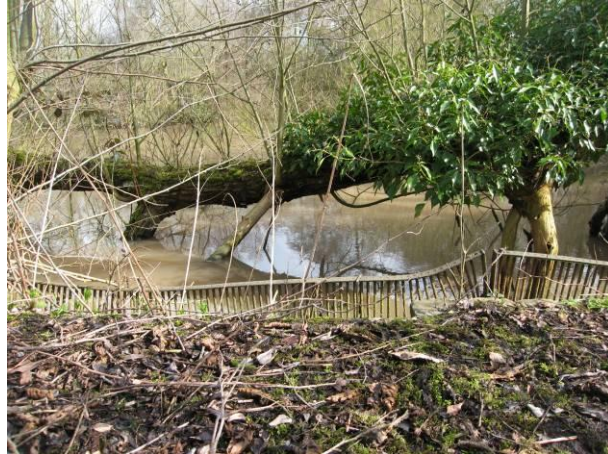
Plate 19

channelled down the cascade (**Plate 19**). There is a brick-lined (uncovered) circular cistern in the bank immediately north of the structure (**Plate 20**). This is overgrown and represents a safety hazard.

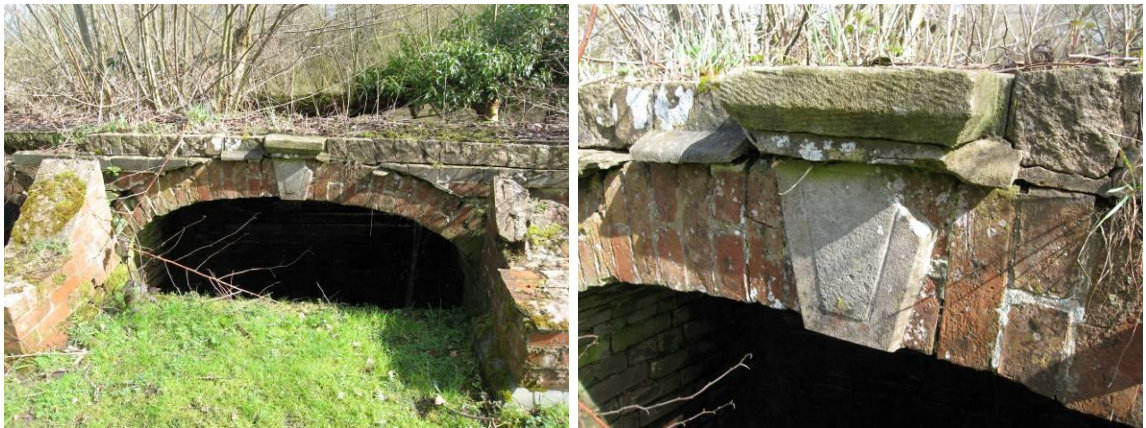
Plate 21

4.3.1.35 The structure is in extremely poor condition. At the south end, partial collapse of masonry has caused a breach and water is finding its way through around the edge of the structure (**Plate 22**). The water flow varies within each cell, suggesting that there are blockages in the system. None of the buttresses is in good condition - these are not bonded into the walling and most are being pushed outwards and collapsing. The brick arches are in danger of collapse, with dropped and missing bricks and decayed mortar (**Plate 23**). Sections of the stone capping from the top of the structure have been lost (including most of the fronting stones which appear originally to have had a moulded facing - one small section of this survives to the central arch but the remainder appears to have delaminated and fallen away - see **Plate 21**).

4.3.1.36 Notwithstanding any more fundamental structural problems that may be present, the loss of large sections of the stone capping and the decayed mortar to the brickwork is

contributing to the structure's apparently increasing incapacity to resist the various pressures upon it.

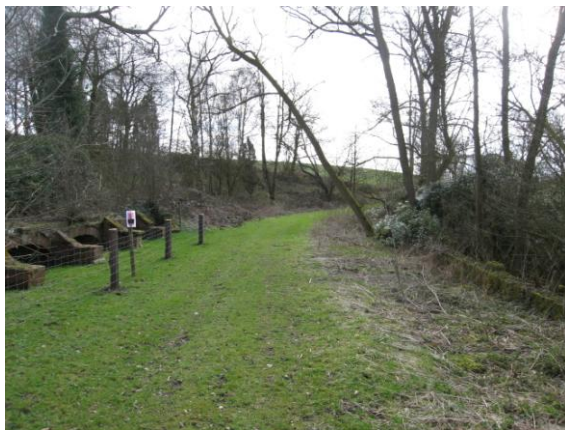
Plate 24

4.3.1.37 To the south the second element of the structure (running parallel with the dam) comprises another brick retaining wall, projecting above ground level (**Plate 24**) and continuing down to the ground level of an area of small linked holding ponds below, which feed into the Lin Brook (**Plate 25**). A semi-circular structure abuts the south side of the wall, at water level, possibly the top of a cistern or well into the base of which the water from the weir is channelled underground (**Plate 26**). Other partly-submerged arched outlets are visible at the base of the wall (**Plate 27**).

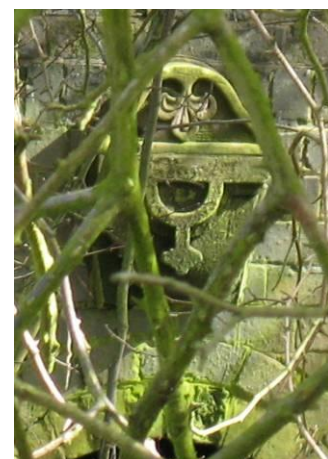
Plate 29

4.3.1.39 The south face of the wall incorporates some attractive decorative carved stone features; in the centre, a scrolled stone 'pediment' projects above the wall, with a crest below surrounded by carved foliage. The feature is difficult to access but it appears that the details of the crest have in any case been eroded (**Plate 28**). There is another carved stone crest-type feature above the smaller arched opening at the base of the structure (**Plate 29**).

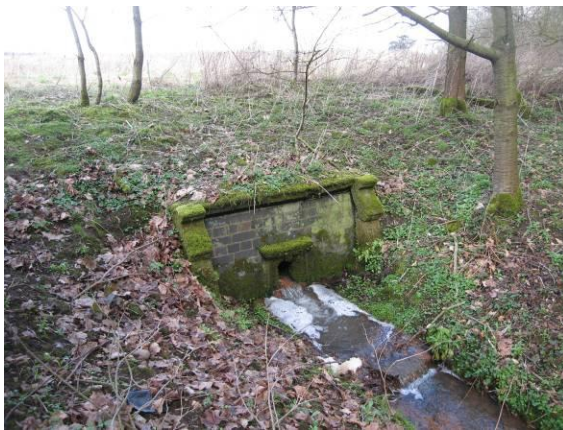
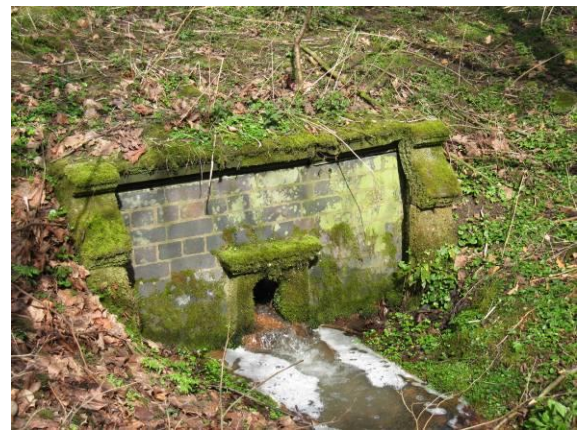
4.3.1.40 South-west of the overflow structure is the outflow from a brick culvert or conduit, which presumably drains water off the land eastwards into the Lin Brook. The conduit facing has been given a decorative treatment, perhaps because of its location close to the overflow structure, with which it presumably is contemporaneous. It is built of blue engineering brick laid in English Bond, capped with a moulded stone slab and flanked by stone piers incorporating volutes. The outlet itself is framed by a stone 'portal' with round-arched aperture (**Plates 30 and 31**).

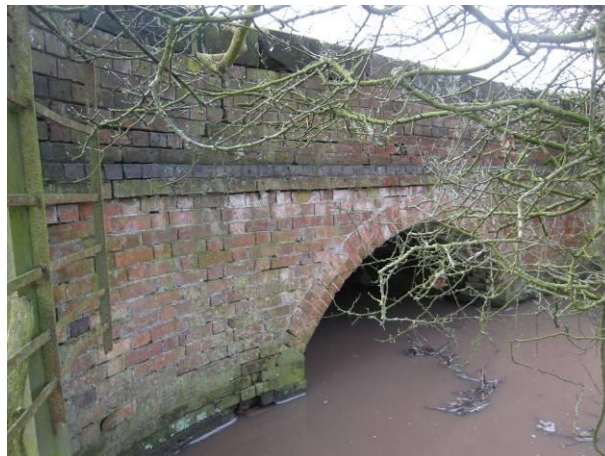
Plate 32

4.3.1.43 This structure, a footbridge over the Lin Brook (**Plate 32**), lies immediately outside the eastern boundary of the application site. A footbridge is shown in this location on the 1883 O.S. map.

4.3.1.45 The brickwork of the bridge is in poor repair with significant areas of re-pointing required; the upper part of the north wall for instance, may be liable to collapse if this is not addressed.

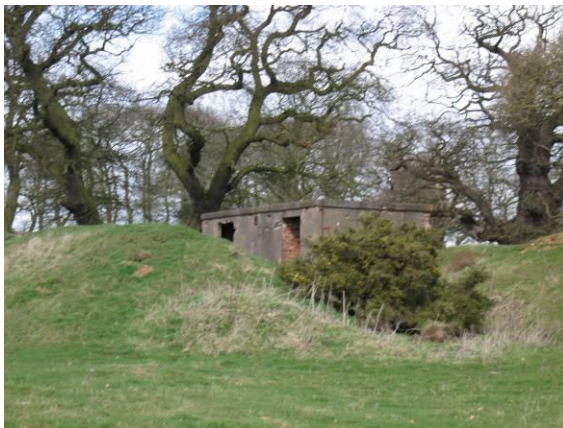
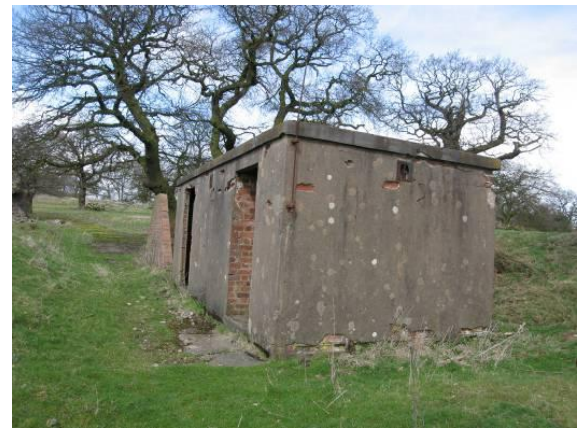
Plate 33

4.3.1.53 The bomb store that lies furthest to the south (**Plate 33**) comprises a single bay surrounded by earthworks with a brick traverse blast-wall and containing a single flat-roofed brick-built cement-rendered structure with two entrances in the west side into two separate cells.

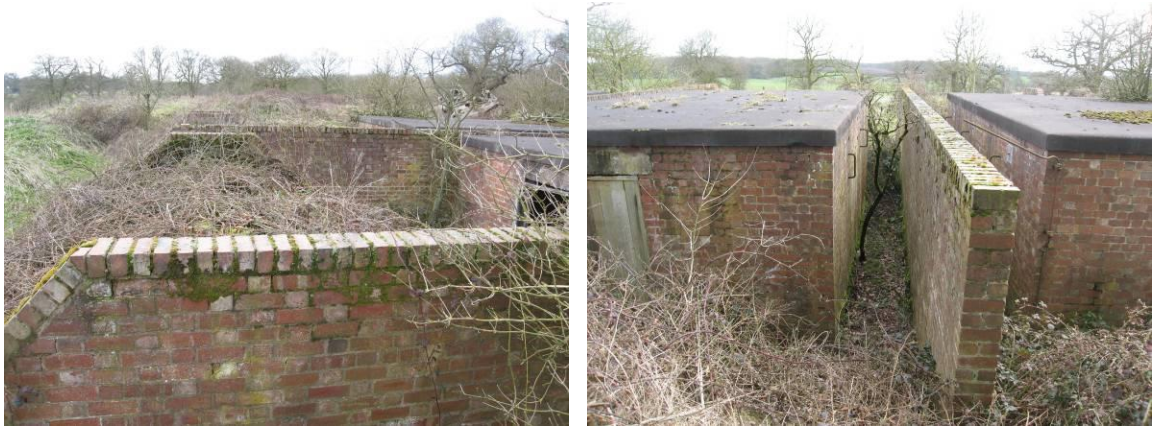
Plate 34

4.3.1.54 North-west of this structure is a three-bay bomb store (apparently built to type 18185/40). Of similar construction to that above, the complex is surrounded by high earthworks and traversed blast-walls (**Plate 34**).
