**STATEMENT OF
SIGNIFICANCE**

**ST. GEORGE'S PARK,
NATIONAL FOOTBALL
CENTRE**

**THE FOOTBALL
ASSOCIATION**

Date: April 2010

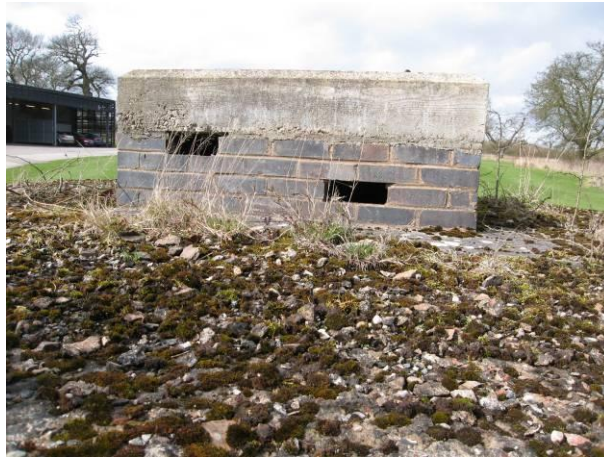
Plate 5

4.3.1.12 The icehouse has an octagonal plan form and is constructed of blue engineering brick laid in English bond. The superstructure comprises the above-ground sections of the walls of the ice pit, which is largely below ground level. This is capped with concrete and has a central brick projection, also capped with concrete and with a central aperture (**Plate 5**). The projection has vent holes. Part of the superstructure may have been lost.

4.3.1.14 The building appears in fair condition, although the concrete capping to the main superstructure is deteriorating.

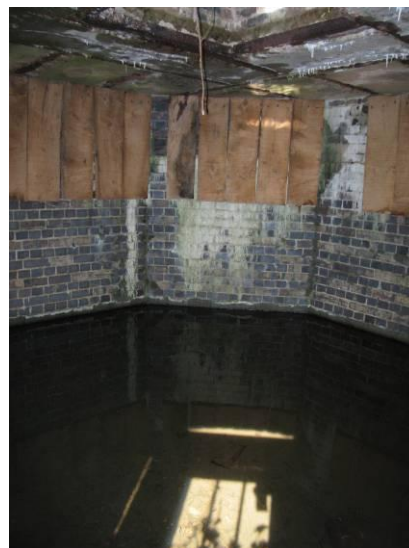
Plate 6

4.3.1.13 The interior of the icehouse is accessed from the south side via a flight of steps down below ground level and flanked by brick retaining walls (**Plate 6**). The ice would be tipped through the top of the superstructure and collected for use via the door opening. The square-headed door, set beneath a brick segmental-arched head, appears to be a modern replacement with barred unglazed vent to the top half. The interior of the building was inaccessible due to flooding, but could be viewed through the door vent, from where **Plate 6** was taken. The ice pit can be seen to cover the whole of the interior space. The upper parts of the internal walls have been partly clad with vertical boarding, the purpose of which is not clear.

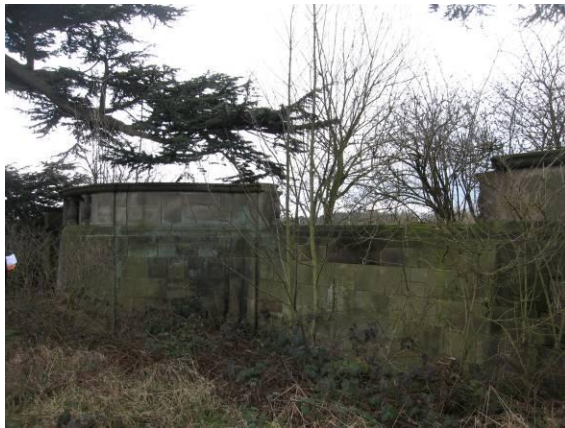
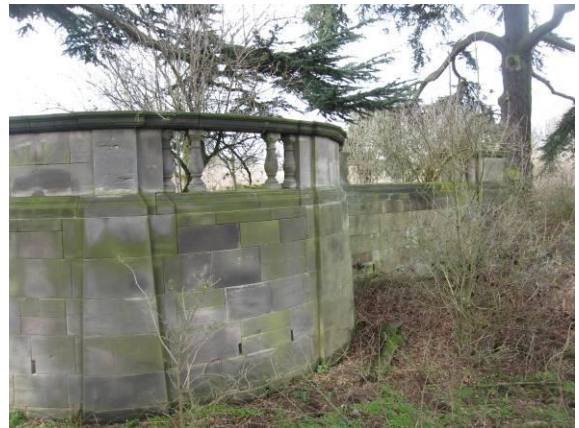
- 4.3.1.21 The section that survives today comprises the north-east corner of the terrace. It is largely built of brick faced with coursed grey-toned ashlar, but may also incorporate some masonry blocks. The section aligned north-south (**Plates 7 and 8**) comprises a length of high wall (c.1.5-2m) incorporating a projecting bowed section with shallow angled buttresses creating a viewing 'platform' positioned to maximise views eastwards across parkland to the Lin Brook and the rising parkland landscape beyond it. The wall is surmounted by infilled panels alternating with sections of balustrading, the whole topped with a wide moulded stone cap rail (**Plate 9**). Much of the balustrading and capping has been removed from this section. The inside of the bowed section contains a carved oval recess to each junction with the walling to either side (**Plate 10**).

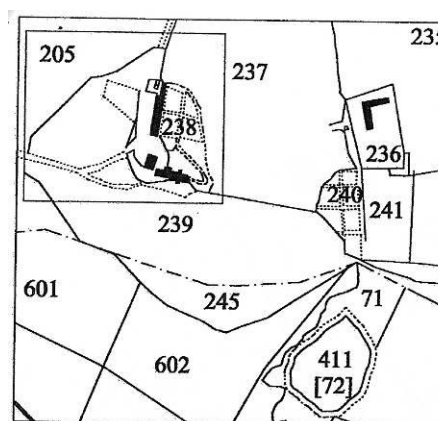
Plate 12: 1805

4.3.1.27 There are several weirs along the Lin Brook, and two large fish ponds. The brook runs just outside the eastern boundary of the application site. The enclosure map of 1805 depicts a pool (Brickley Pool, numbered 411; see **Plate 12**) in the general location of the current fishponds but a plan of the site in 1859 (drawn up for conveyancing purposes when the estate passed from the Sneyd family to Francis William Newdigate), shows that this pond had been entirely reconfigured and replaced by two new connected ponds (**Plate 13**). It would thus appear that the Sneyd family created the two ponds between 1805 and 1859.

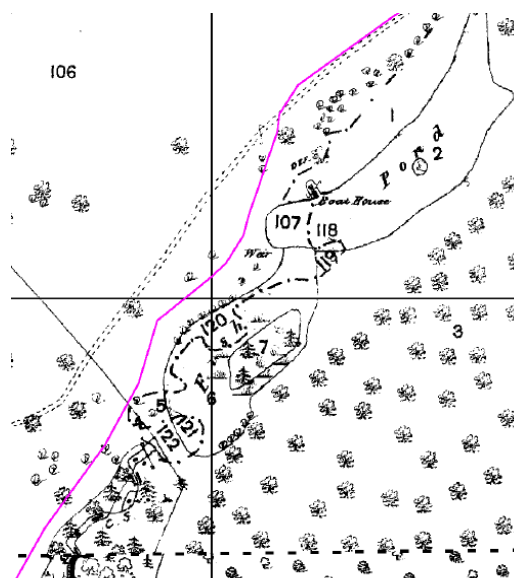
Plate 14: 1883

4.3.1.29 In the area marked No. 4 on Figs. 1 and 2 there is a large built structure marked as an 'overflow' on the historic O.S. maps from 1924 onwards. This structure appears most likely to have been constructed between 1859 and 1883 by F.W. Newdigate during his occupation of the estate; the southern end of the south pond certainly appears to have been reconfigured during this period (**Plate 14**) and it is likely that the construction of the overflow formed part of these works.

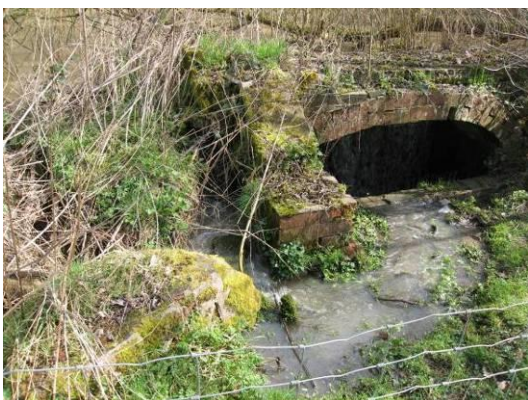
Plate 22

4.3.1.35 The structure is in extremely poor condition. At the south end, partial collapse of masonry has caused a breach and water is finding its way through around the edge of the structure (**Plate 22**). The water flow varies within each cell, suggesting that there are blockages in the system. None of the buttresses is in good condition - these are not bonded into the walling and most are being pushed outwards and collapsing. The brick arches are in danger of collapse, with dropped and missing bricks and decayed mortar (**Plate 23**). Sections of the stone capping from the top of the structure have been lost (including most of the fronting stones which appear originally to have had a moulded facing - one small section of this survives to the central arch but the remainder appears to have delaminated and fallen away - see **Plate 21**).

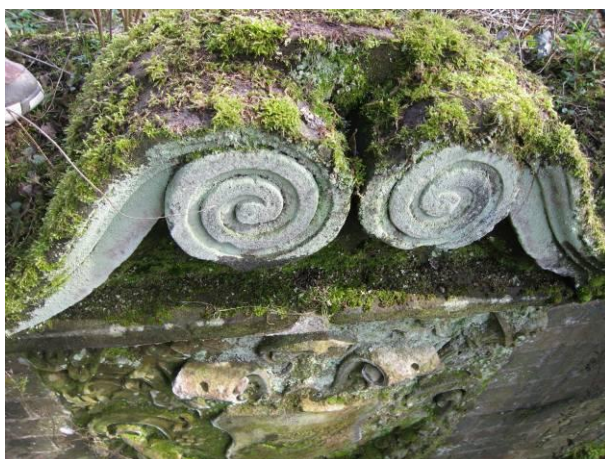
Plate 28

4.3.1.39 The south face of the wall incorporates some attractive decorative carved stone features; in the centre, a scrolled stone 'pediment' projects above the wall, with a crest below surrounded by carved foliage. The feature is difficult to access but it appears that the details of the crest have in any case been eroded (**Plate 28**). There is another carved stone crest-type feature above the smaller arched opening at the base of the structure (**Plate 29**).
